TRIP REPORT

TO: JFO File: Chuck Hayes / SOP-12017

Subject: 7-25-16 Site Visit in response to spill at Chuck Hayes Facility

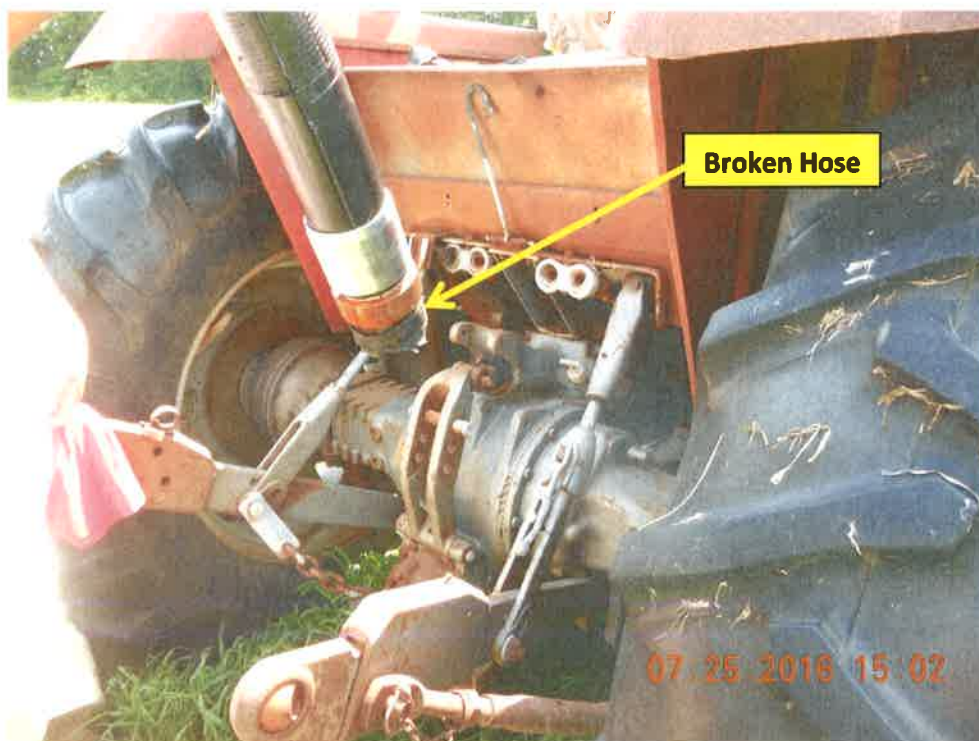
Picture 1

Date of Photo: 7/25/16. Photo taken by: Kevin Smith. Location/Site Name: Chuck Hayes/SOP-12017. TDWR personnel Present: Kevin Smith. Remarks: Picture is of hose which broke and caused the hog wastewater spill.

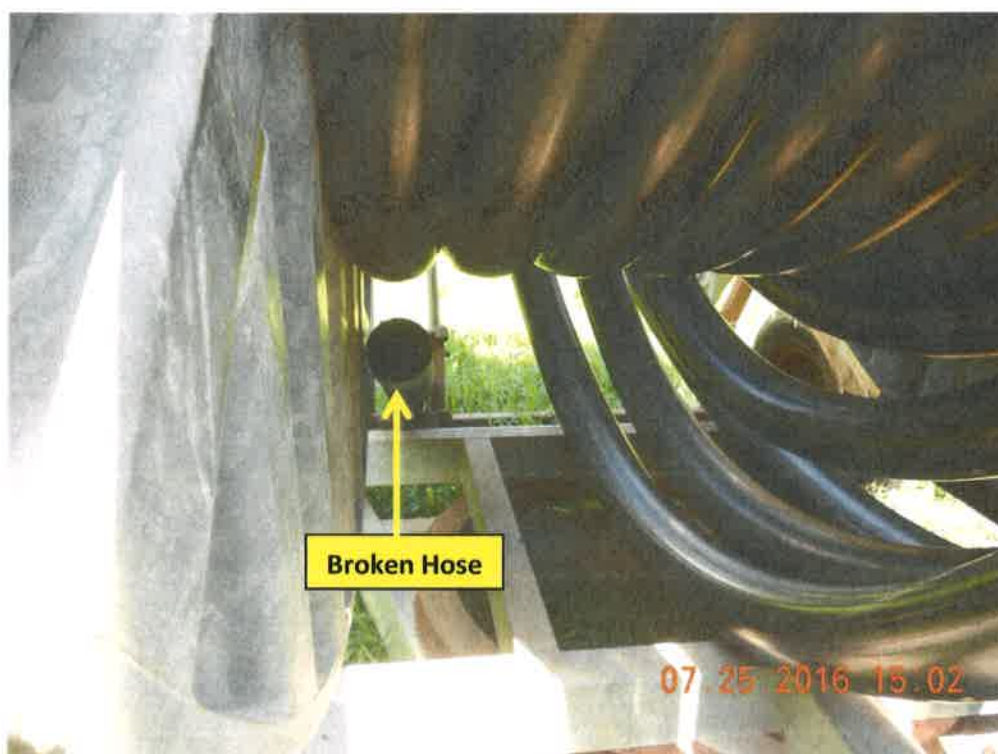
Picture 2

Date of Photo: 7/25/16. Photo taken by: Kevin Smith. Location/Site Name: Chuck Hayes/SOP-12017. TDWR personnel Present: Kevin Smith. Remarks: Picture is of the other half of the hose that was broke in Picture 1.

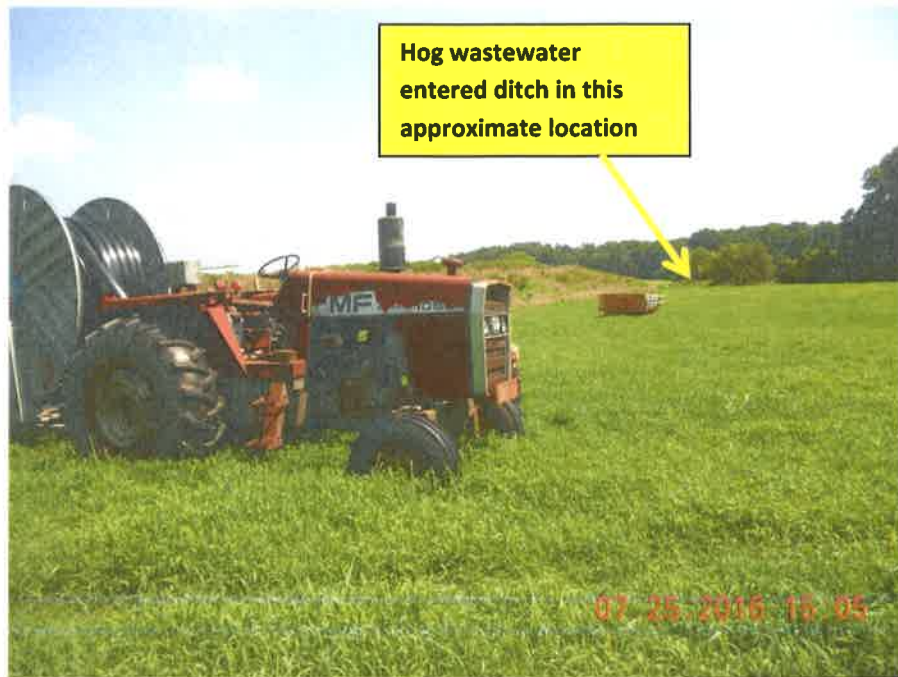
Picture 3

Date of Photo: 7/25/16. Photo taken by: Kevin Smith. Location/Site Name: Chuck Hayes/SOP-12017. TDWR personnel Present: Kevin Smith. Remarks: Picture is of reel used to apply hog wastewater to field. When the hose shown in Pictures 1 and 2 broke wastewater pooled in the field and flowed south approximately 200 yards before entering into a drainage ditch. Picture was taken facing south.

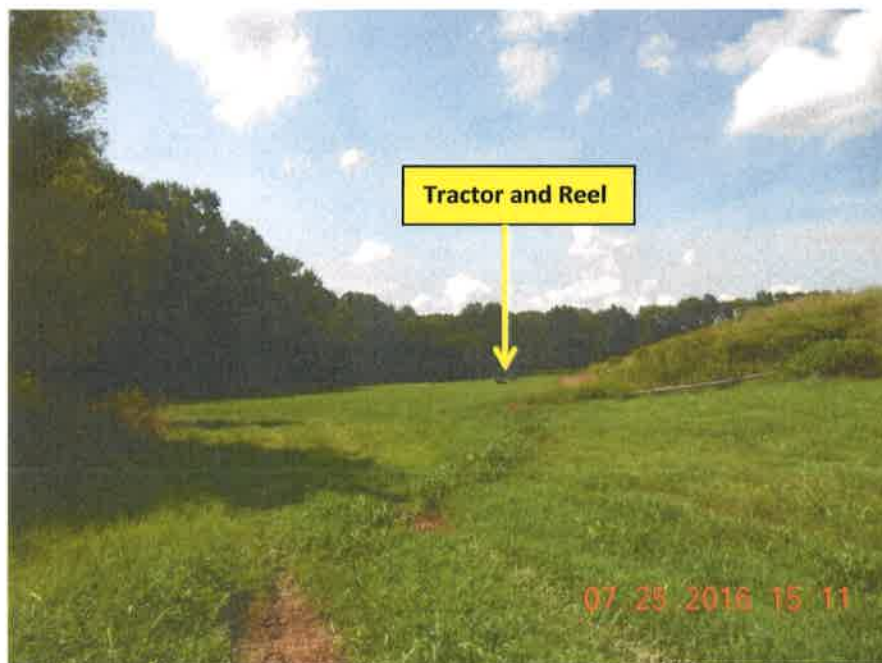
Picture 4

Date of Photo: 7/25/16. Photo taken by: Kevin Smith. Location/Site Name: Chuck Hayes/SOP-12017. TDWR personnel Present: Kevin Smith. Remarks: Picture was taken at point indicated by Mr. Barron and Mr. Hayes that hog wastewater started leaving field and entering drainage ditch. It appeared the hog wastewater traveled approximately 200 yards south before entering drainage ditch. Picture was taken facing north back towards tractor and reel.

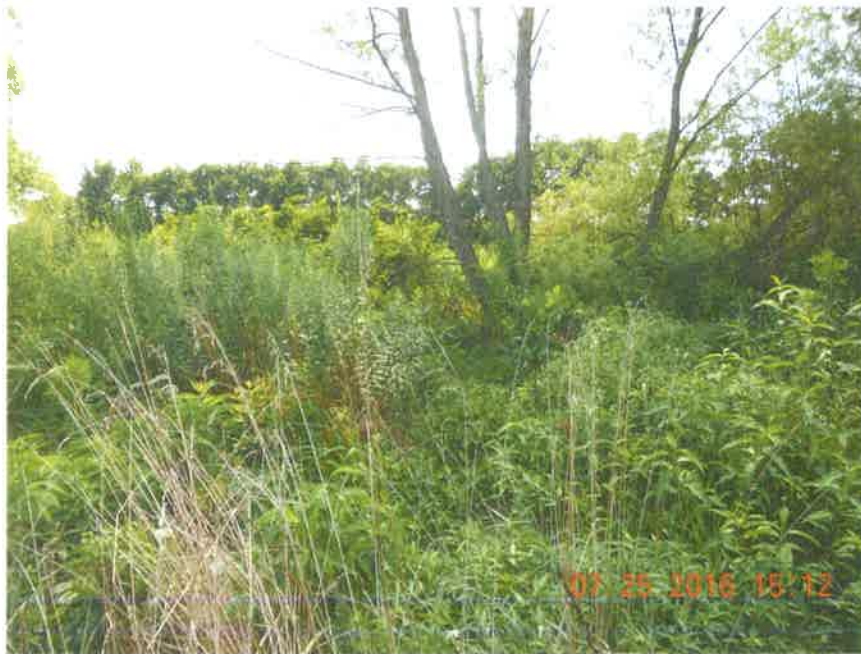
Picture 5

Date of Photo: 7/25/16. Photo taken by: Kevin Smith. Location/Site Name: Chuck Hayes/SOP-12017. TDWR personnel Present: Kevin Smith. Remarks: Picture was taken from same location as Picture 4 only now I am facing west/southwest towards drainage ditch. It was grown up around drainage ditch and channel was not well defined.

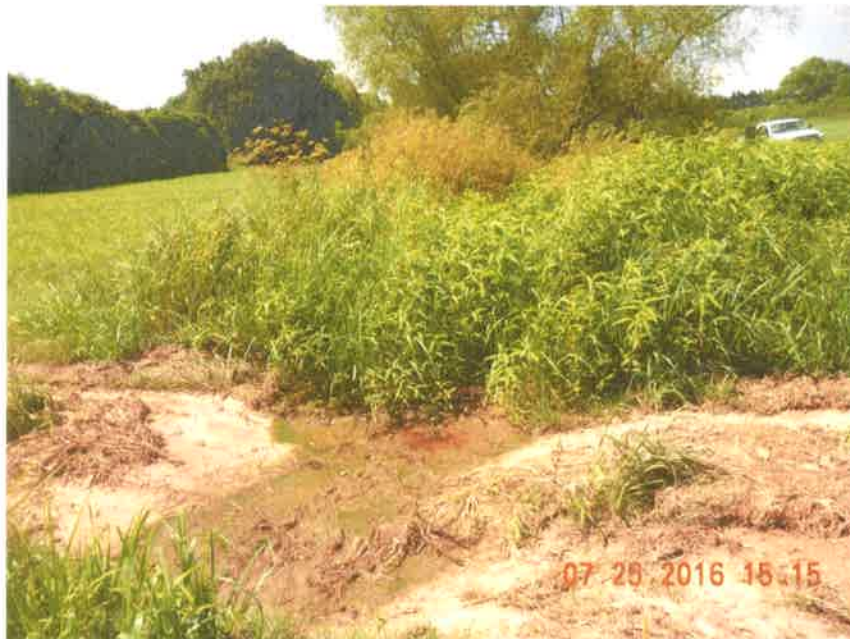
Picture 6

Date of Photo: 7/25/16. Photo taken by: Kevin Smith. Location/Site Name: Chuck Hayes/SOP-12017. TDWR personnel Present: Kevin Smith. Remarks: Picture was taken further south down drainage ditch which hog wastewater flowed to. Channel of ditch is a little more defined than what it was further north where hog wastewater first started entering ditch. A skid steer was used in this location to scoop pooled wastewater from ditch and dump over in application field. This location is up-gradient of dams that were built to stop the flow of wastewater down the drainage ditch.

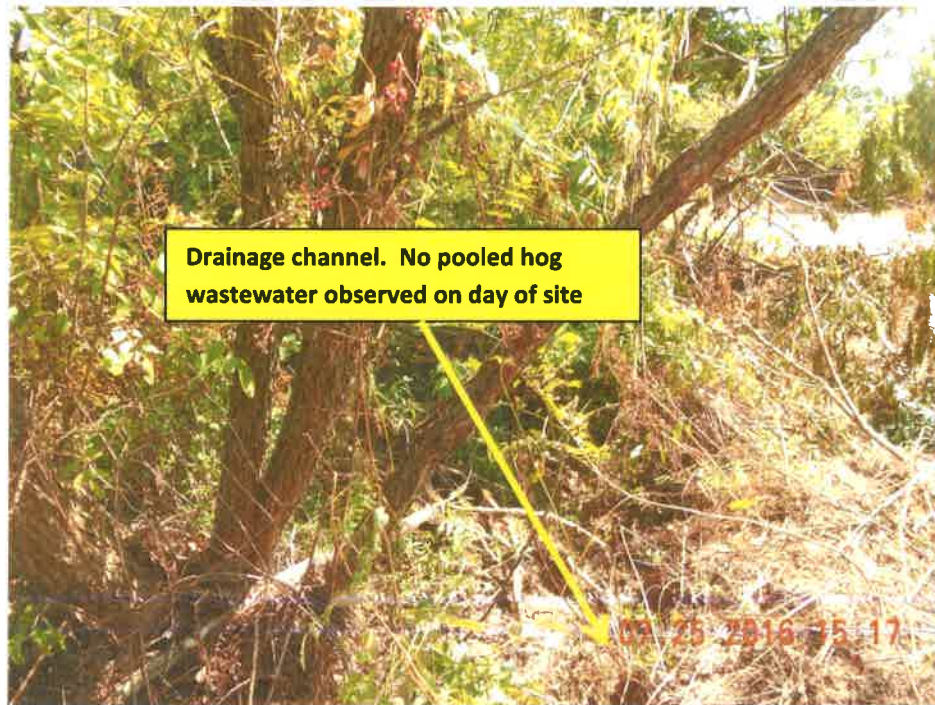
Picture 7

Date of Photo: 7/25/16. Photo taken by: Kevin Smith. Location/Site Name: Chuck Hayes/SOP-12017. TDWR personnel Present: Kevin Smith. Remarks: Picture is of drainage ditch down-gradient of location shown in Picture 6 and immediately up-gradient of the first dam put in place to stop the flow of wastewater. Drainage ditch was dry in this location on day of visit.

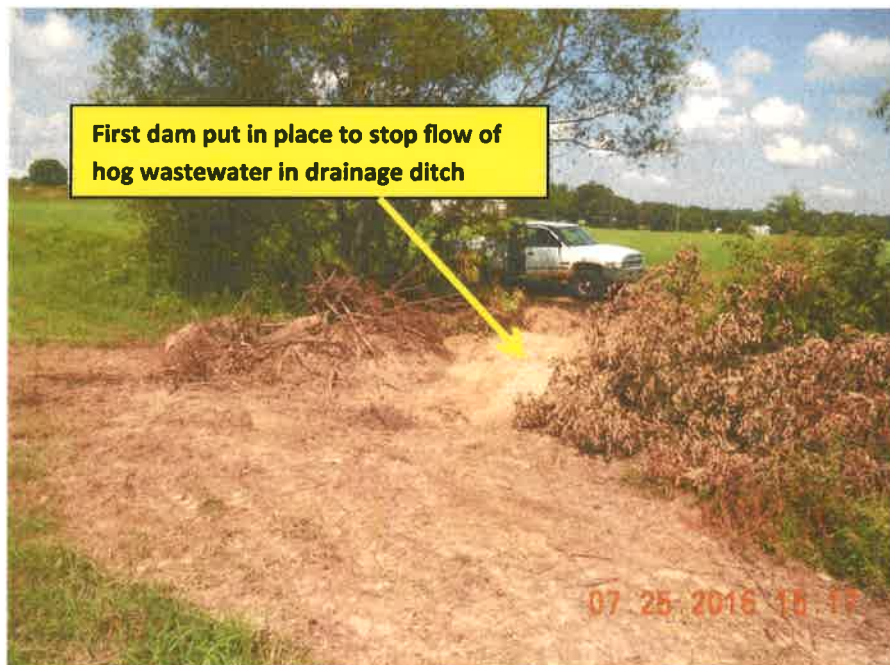
Picture 8

Date of Photo: 7/25/16. Photo taken by: Kevin Smith. Location/Site Name: Chuck Hayes/SOP-12017. TDWR personnel Present: Picture is of where first dam was built to stop the flow of hog wastewater down drainage ditch. A skid steer was used to push dirt into the drainage ditch. Picture was taken standing on west side of drainage ditch facing northeast.

Mr. Barron showed me the location of the dams he made in the drainage in an effort to stop the wastewater from continuing to flow down the drainage ditch (Pictures 8-10; Figure 1). Mr. Barron made the dams by pushing dirt in the drainage ditch. Mr. Barron made a second dam after they seen that some wastewater was trickling through the first dam. I did not observe pooled wastewater in the drainage ditch up-gradient or immediately down-gradient of the area where the dams were put in place (Pictures 7 and 11). Mr. Barron indicated he was using the bucket of a skid steer to dip wastewater out of the drainage ditch up-gradient of the dams he had made and then was dumping it in an area of the field away from the drainage ditch, which had not received wastewater (Picture 6). I did observe pooled wastewater in the drainage ditch further south (down-gradient) toward Jim Merrell Road. The first pooled wastewater I observed was in a bend of the drainage ditch (Figure 1; Pictures 14-15). There was quite a bit of pooled wastewater between the bend where I first observed the pooled wastewater and Jim Merrell Road (Figure 1; Pictures 14-18). Mr. Barron indicated that they pumped most of the wastewater out of the drainage ditch on Friday July 22, 2016 but they received approximately 0.2 inches of rain on Saturday July 23, 2016. Mr. Barron didn't know if that rainfall event might have washed some wastewater down the drainage ditch or if there was some wastewater that worked its way on down the drainage ditch after they stopped pumping out the drainage ditch on the night of July 22, 2016. Mr. Hayes indicated according to the pump truck drivers approximately 20,000 gallons of wastewater was pumped out of the drainage ditch on Friday July 22, 2016.

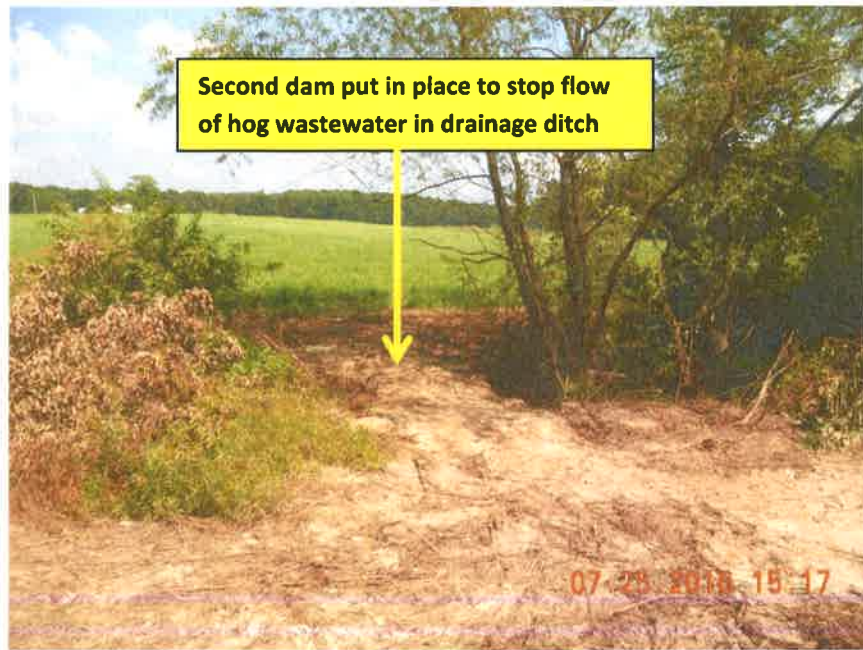
Picture 9

Date of Photo: 7/25/16. Photo taken by: Kevin Smith. Location/Site Name: Chuck Hayes/SOP-12017. TDWR personnel Present: Kevin Smith. Remarks: Picture is of 2nd dam put in place. Hog wastewater was seeping through the first dam put in place so a second dam was put in place to try to stop the flow. Picture was taken on west side of drainage ditch facing east/southeast.

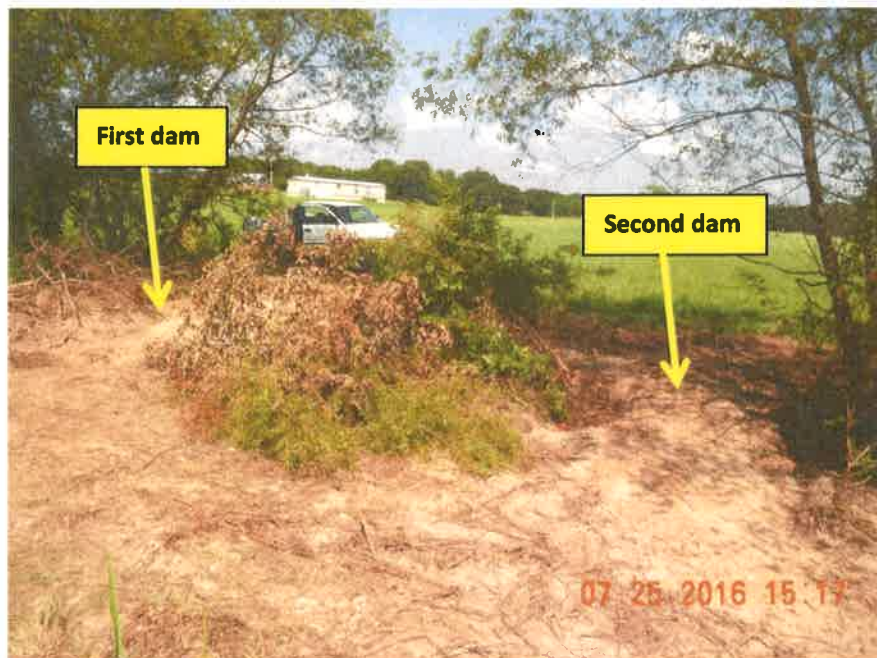
Picture 10

Date of Photo: 7/25/16. Photo taken by: Kevin Smith. Location/Site Name: Chuck Hayes/SOP-12017. TDWR personnel Present: Kevin Smith. Remarks: Picture is of the two dams that were put in place to stop the flow of hog wastewater in the drainage ditch. Picture was taken standing on west side of drainage ditch facing east/northeast.

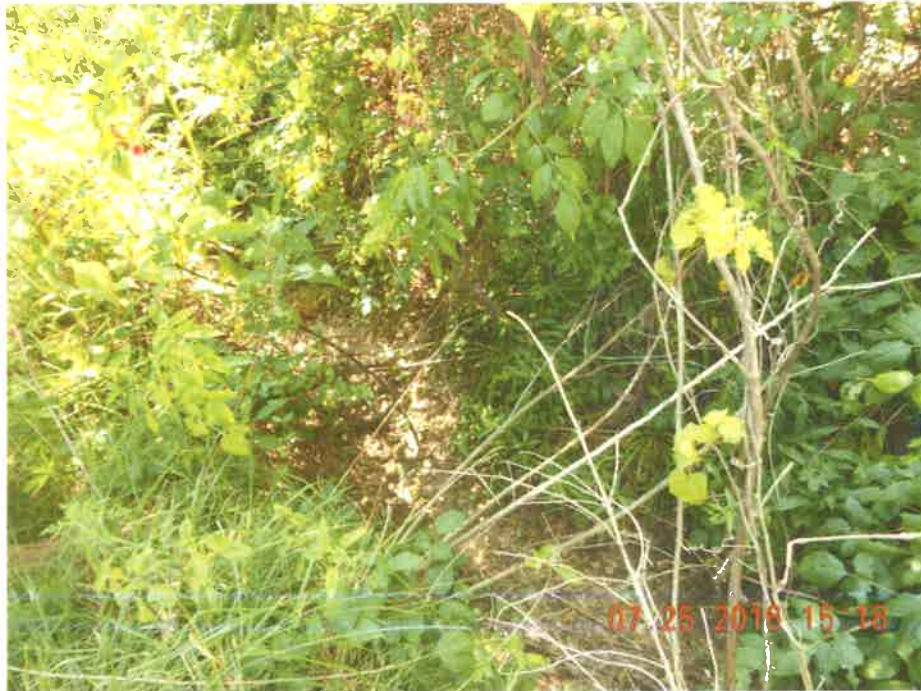
Picture 11

Date of Photo: 7/25/16. Photo taken by: Kevin Smith. Location/Site Name: Chuck Hayes/SOP-12017. TDWR personnel Present: Kevin Smith. Remarks: Picture is of drainage ditch immediately down-gradient of the dams. Drainage ditch immediately down-gradient of dams was dry on day of site visit.

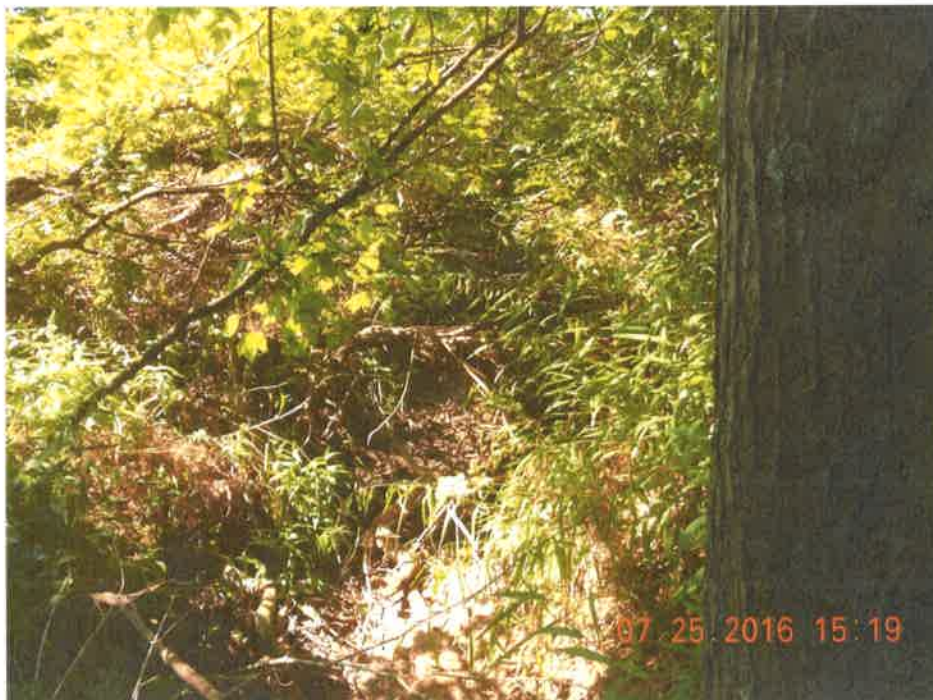
Picture 12

Date of Photo: 7/25/16. Photo taken by: Kevin Smith. Location/Site Name: Chuck Hayes/SOP-12017. TDWR personnel Present: Kevin Smith. Remarks: Picture is of drainage ditch and was taken a little further down-gradient of Picture 11. Drainage ditch was dry in this location on day of visit. I took this picture facing up-gradient towards dams.

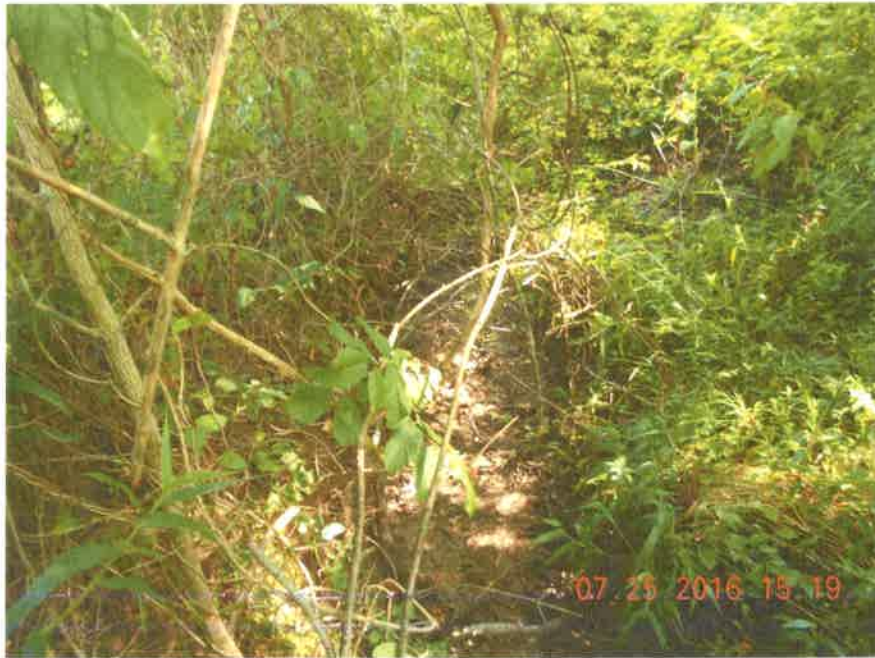
Date of Photo: 7/25/16. Photo taken by: Kevin Smith. Location/Site Name: Chuck Hayes/SOP-12017. TDWR personnel Present: Kevin Smith. Remarks: Picture 13 was taken standing in same location as Picture 12 only now I am facing down-gradient. Drainage ditch was dry in this location on the day of my visit.

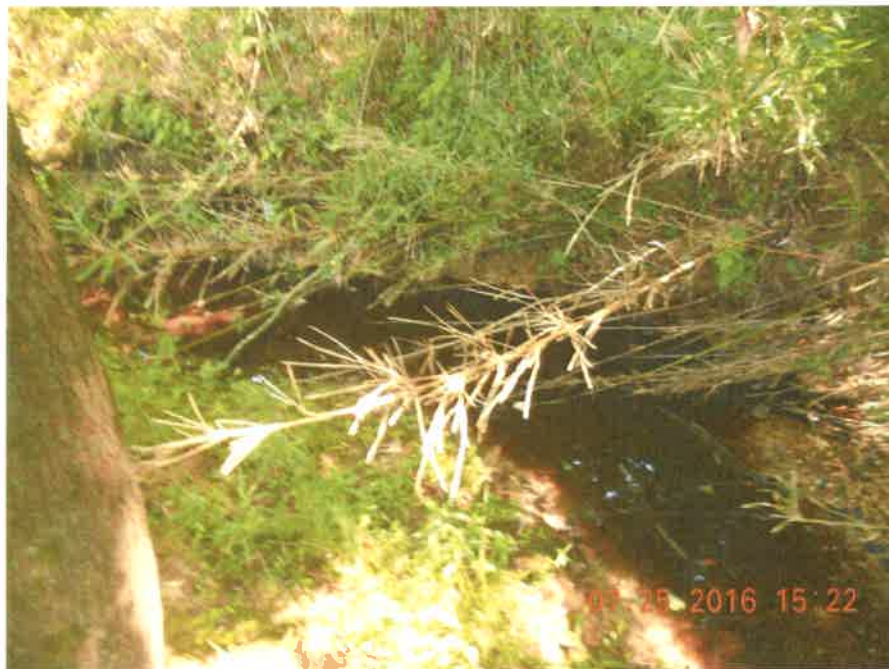
Picture 14

Date of Photo: 7/25/16. Photo taken by: Kevin Smith. Location/Site Name: Chuck Hayes/SOP-12017. TDWR personnel Present: Kevin Smith. Remarks: Picture was taken further down-gradient from Pictures 12 and 13 in bend of drainage ditch. This was a low spot in drainage ditch. There was what appeared to be hog wastewater pooled in this location on the day of my visit. It was indicated that this area was pumped out on day of spill but there was a 0.2 inch rain over the weekend which may have carried some additional wastewater into ditch or wastewater moved on down the drainage ditch after they stopped pumping out the drainage ditch Friday night.

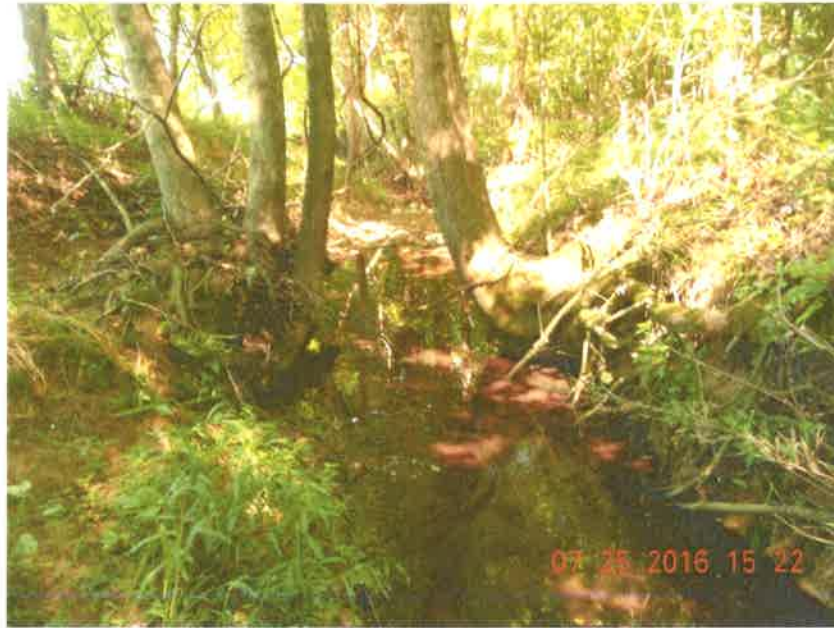
Picture 15

Date of Photo: 7/25/16. Photo taken by: Kevin Smith. Location/Site Name: Chuck Hayes/SOP-12017. TDWR personnel Present: Kevin Smith. Remarks: Picture is of what appears to be more hog wastewater pooled in drainage ditch down-gradient of picture 14. It was indicated that this area was pumped out on day of spill but there was a 0.2 inch rain over the weekend which may have carried some additional wastewater into ditch or wastewater moved on down the drainage ditch after they stopped pumping out the drainage ditch Friday night.

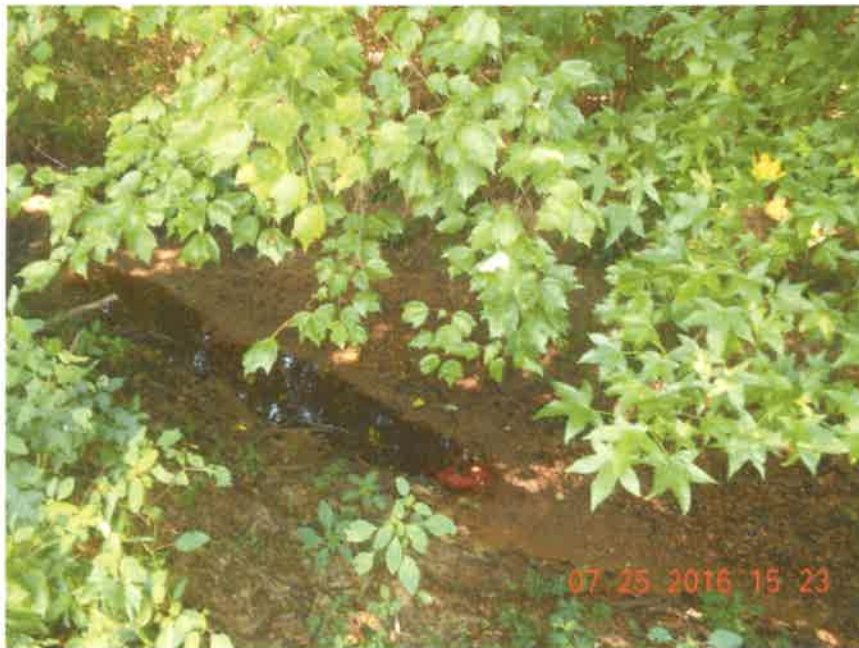
Picture 16

Date of Photo: 7/25/16. Photo taken by: Kevin Smith. Location/Site Name: Chuck Hayes/SOP-12017. TDWR personnel Present: Kevin Smith. Remarks: Picture is of what appeared to be hog wastewater pooled in drainage ditch further down-gradient from picture 15. It was indicated that this area was pumped out on day of spill but there was a 0.2 inch rain over the weekend which may have carried some additional wastewater into ditch or wastewater moved on down the drainage ditch after they stopped pumping out the drainage ditch Friday night.

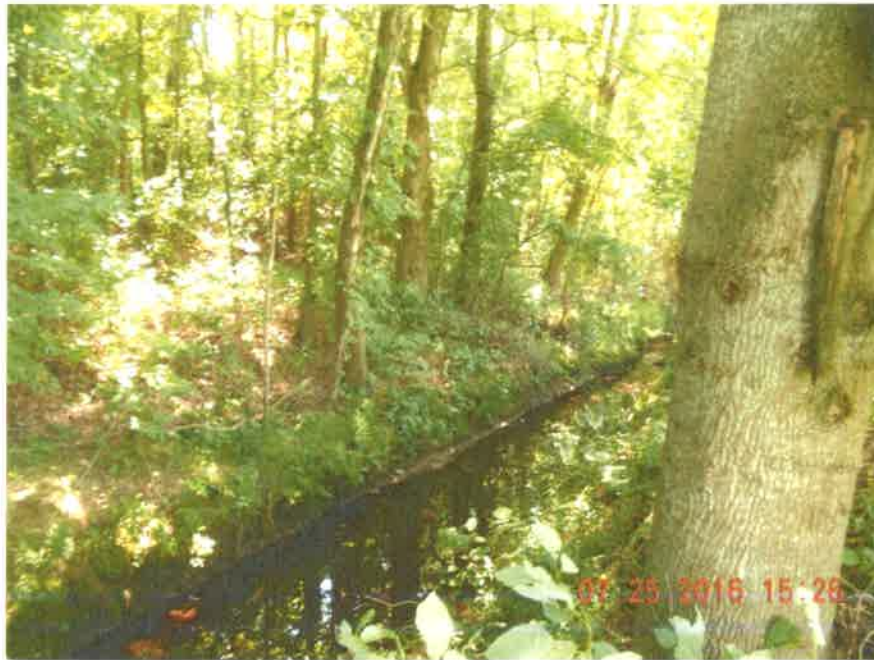
Picture 17

Date of Photo: 7/25/16. Photo taken by: Kevin Smith. Location/Site Name: Chuck Hayes/SOP-12017. TDWR personnel Present: Kevin Smith. Remarks: Picture is of what appears to be hog wastewater in drainage ditch further down-gradient of picture 16. This was largest spot of pooled wastewater observed in drainage ditch. It was indicated that this area was pumped out on day of spill but there was a 0.2 inch rain over the weekend which may have carried some additional wastewater into ditch or wastewater moved on down the drainage ditch after they stopped pumping out the drainage ditch Friday night.

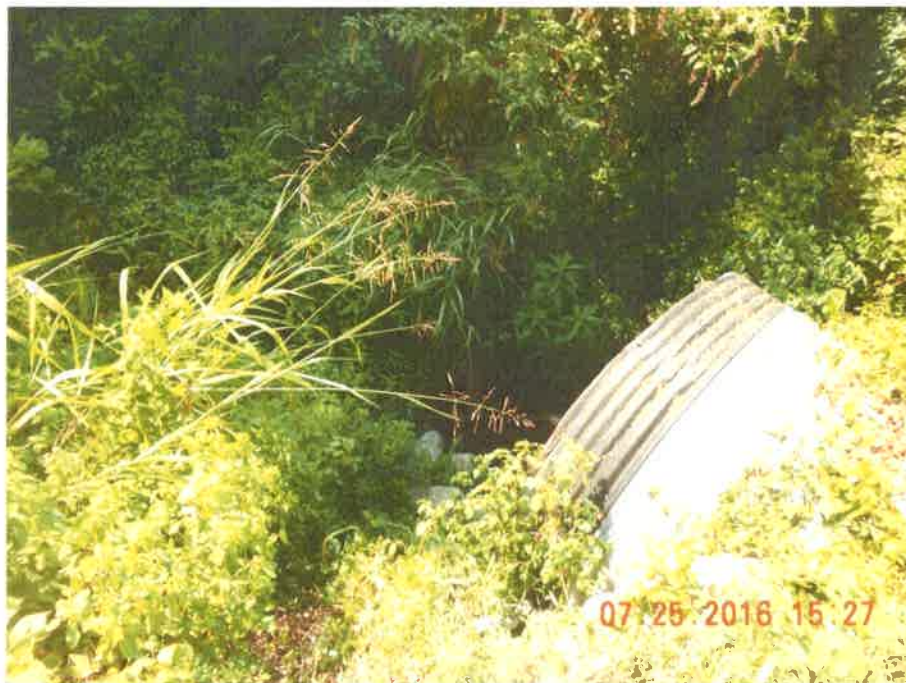
Picture 18

Date of Photo: 7/25/16. Photo taken by: Kevin Smith. Location/Site Name: Chuck Hayes/SOP-12017. TDWR personnel Present: Kevin Smith. Remarks: Picture is of where drainage ditch enters culvert on northside (up-gradient) of Jim Merrell Road. There was what appeared to be hog wastewater pooled in front of the culvert.

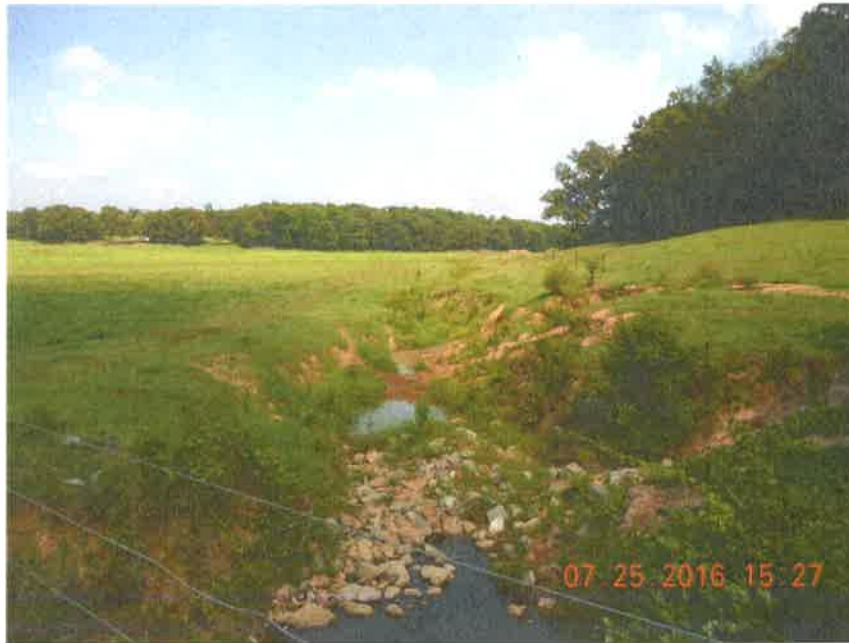
Picture 19

Date of Photo: 7/25/16. Photo taken by: Kevin Smith. Location/Site Name: Chuck Hayes/SOP-12017. TDWR personnel Present: Kevin Smith. Remarks: Picture was taken on southside (downgradient) of the culvert which runs under Jim Merrell Road. There were cattle observed out in this pasture on day of site visit.

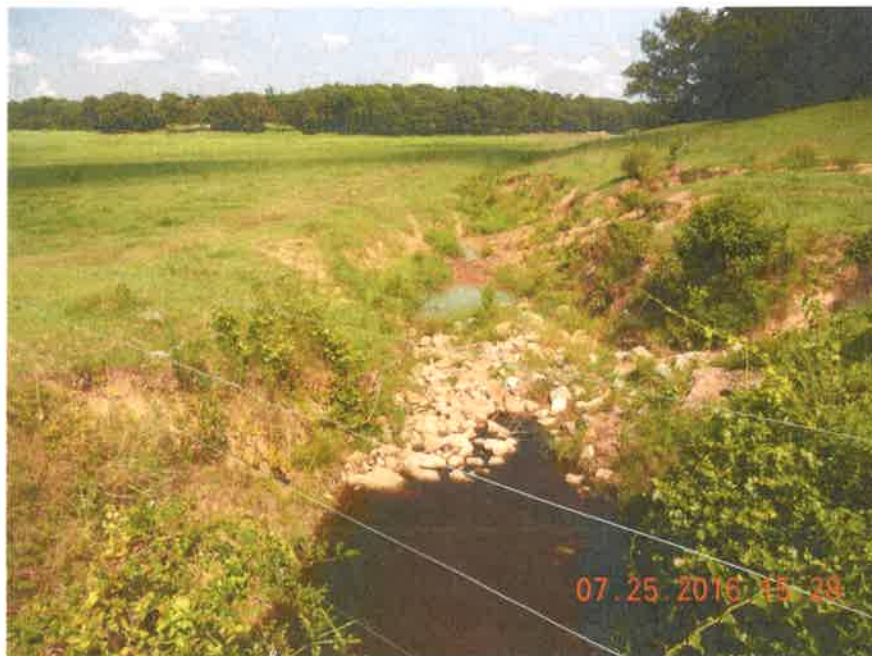
Picture 20

We then walked across Jim Merrell Road and I observed what appeared to be hog wastewater pooled in the drainage ditch on the south side of Jim Merrell Road. Based on the coloration of the water observed in the drainage ditch, it did not appear that the hog wastewater made it passed some rocks that were piled up in the drainage ditch (Pictures 19 and 20). From the point where the hog wastewater entered the drainage ditch to the point where it appears to have stopped on the south side of Jim Merrell Road is approximately 0.3 miles (Figure 2). From the point where the hog wastewater appeared to stop to the confluence of Nelson Creek is approximately 0.8 miles (Figure 2).

Date of Photo: 7/25/16. Photo taken by: Kevin Smith. Location/Site Name: Chuck Hayes/SOP-12017. TDWR personnel Present: Kevin Smith. Remarks: Picture was taken on southside (downgradient) of the culvert which runs under Jim Merrell Road. It appears that the hog wastewater did not go beyond the rocks which are piled up in the drainage ditch. Note the difference in the color of water pooled in front (up-gradient) of the rocks and below (down-gradient) of the rocks. The water pooled in front of the rocks has a dark reddish tint to it, which indicates it may be hog wastewater. The water pooled beyond the rocks was lighter in color and appeared more clear than the water pooled up-gradient of the rocks.

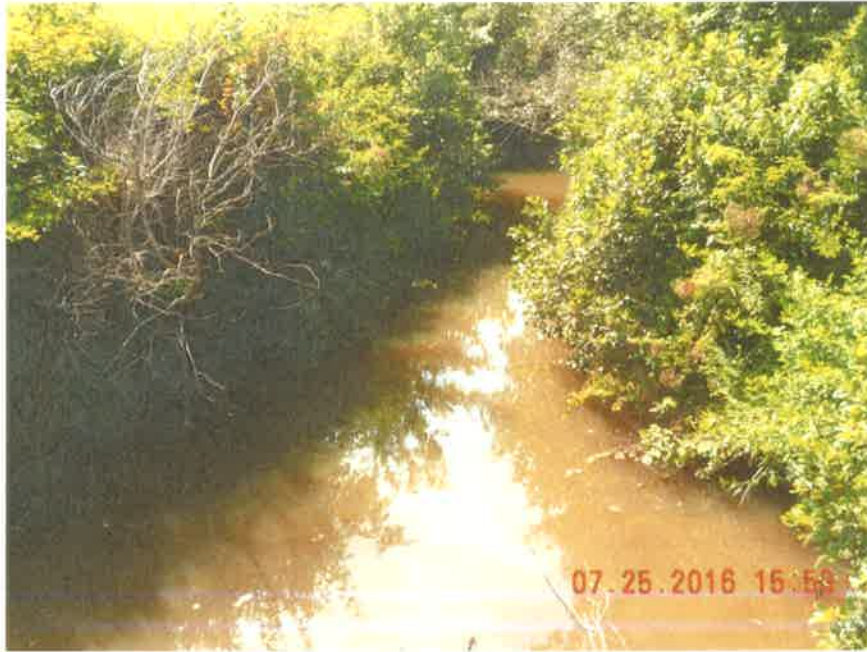
Picture 21

After leaving the facility I stopped on Shady Grove Road where Nelson Creek runs underneath it. I did not observe anything that appeared to be hog wastewater at this location (Pictures 21-22; Figure 2).

Date of Photo: 7/25/16. Photo taken by: Kevin Smith. Location/Site Name: Chuck Hayes/SOP-12017. TDWR personnel Present: Kevin Smith. Remarks: Picture was taken where Nelson Creek runs under Shady Grove Road. Picture was taken on the up-stream side of Shady Grove Road. The drainage ditch which the hog wastewater flowed into eventually drains into Nelson Creek. The water observed at this location on the day of my visit did not have a reddish tint to it like what was observed in the drainage ditch in Picture 20.

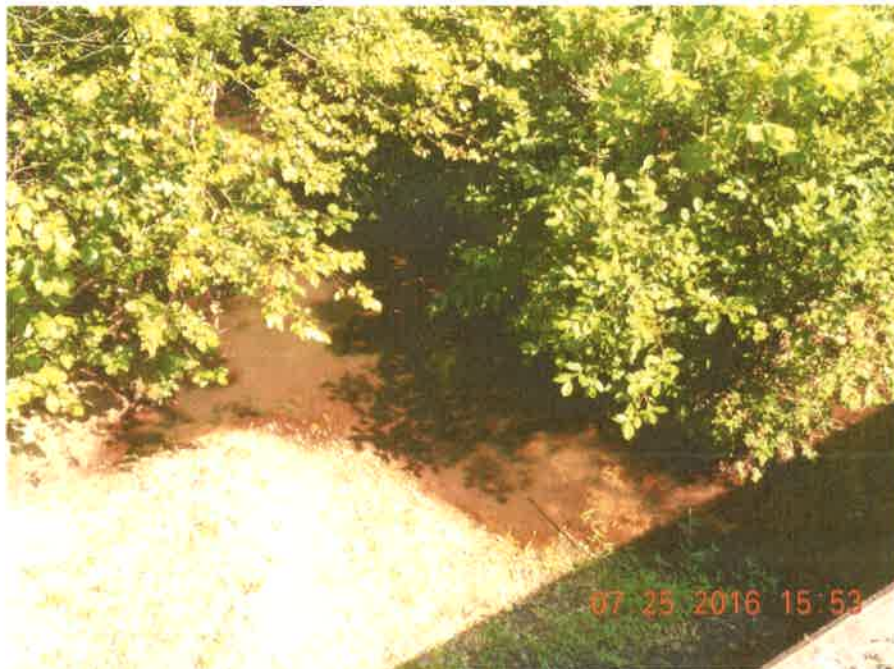
Picture 22

Date of Photo: 7/25/16. Photo taken by: Kevin Smith. Location/Site Name: Chuck Hayes/SOP-12017. TDWR personnel Present: Kevin Smith. Remarks: Picture was taken where Nelson Creek runs under Shady Grove Road. Picture was taken on the down-stream side of Shady Grove Road. The water observed at this location on the day of my visit did not have a reddish tint to it like what was observed in the drainage ditch in Picture 20.

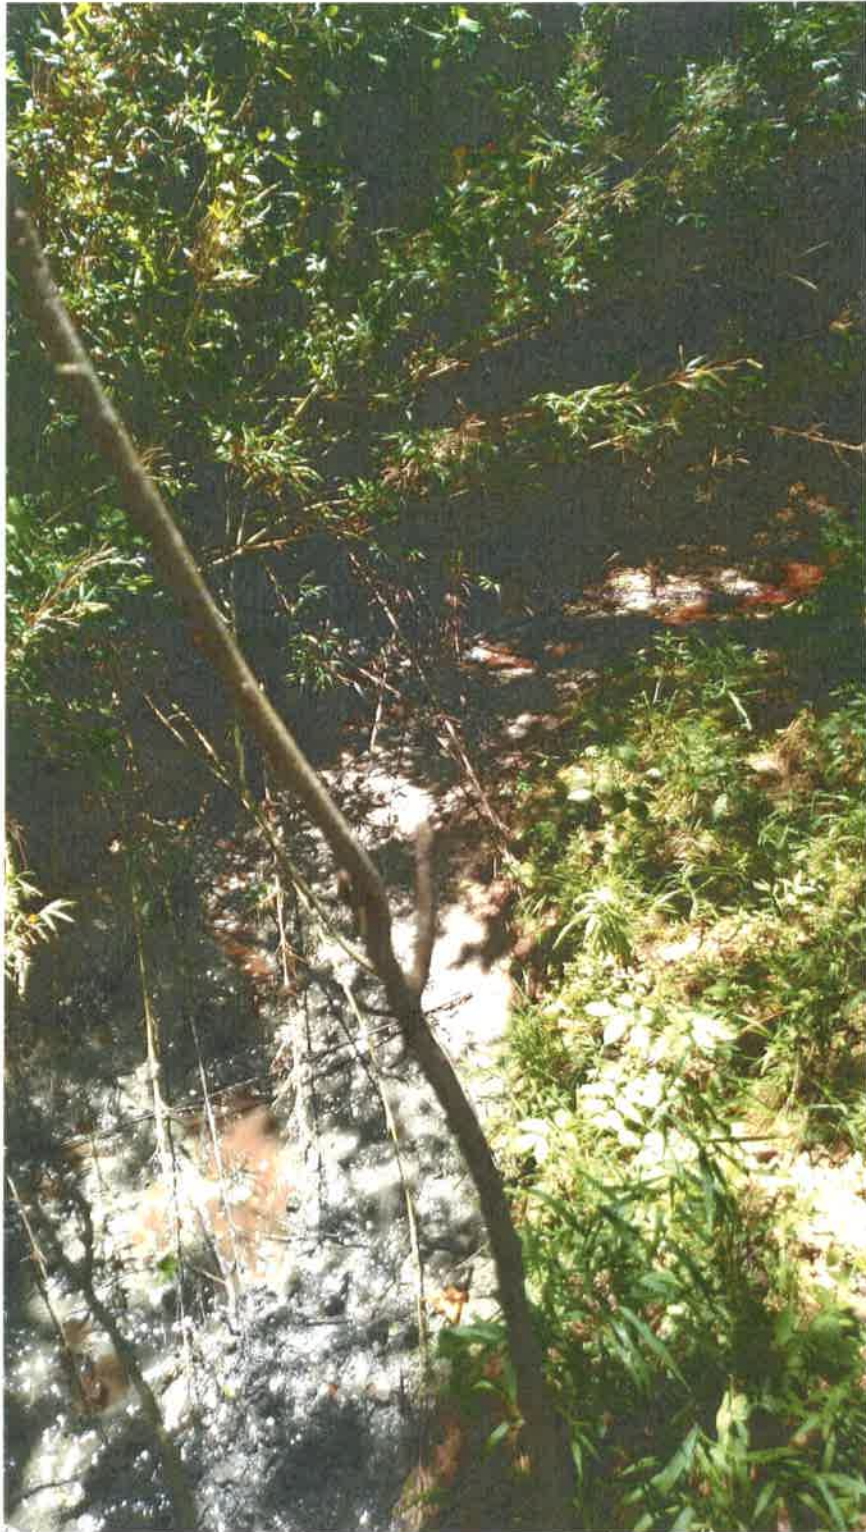
Picture 23

Picture provided by Mr. Chuck Hayes on July 27, 2016 after drainage ditch was pumped out a second time.

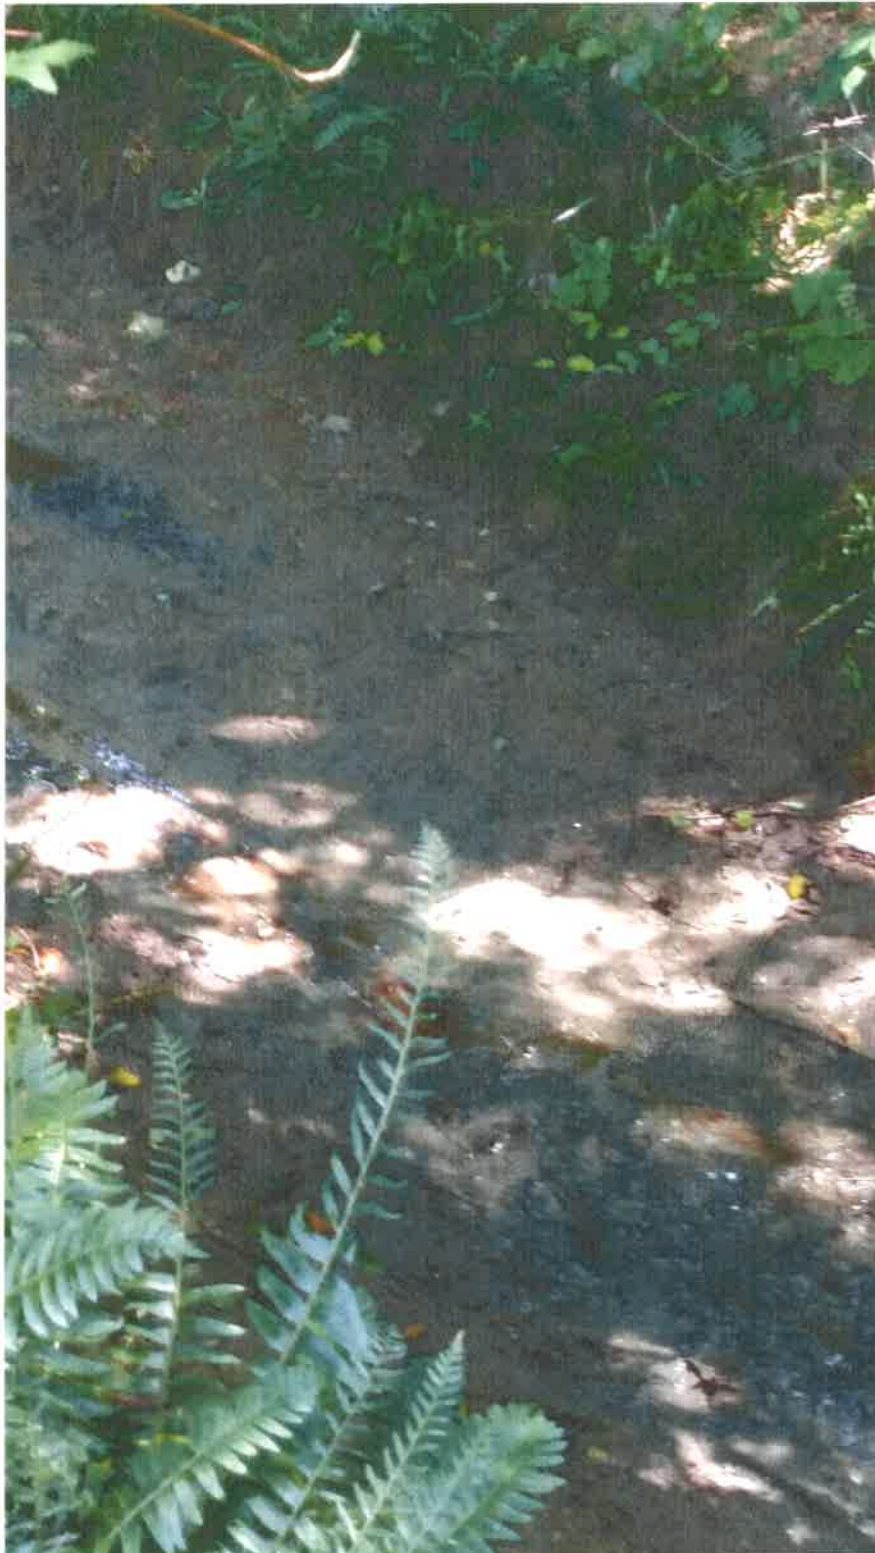
Picture 24

Picture provided by Mr. Chuck Hayes on July 27, 2016 after drainage ditch was pumped out a second time.

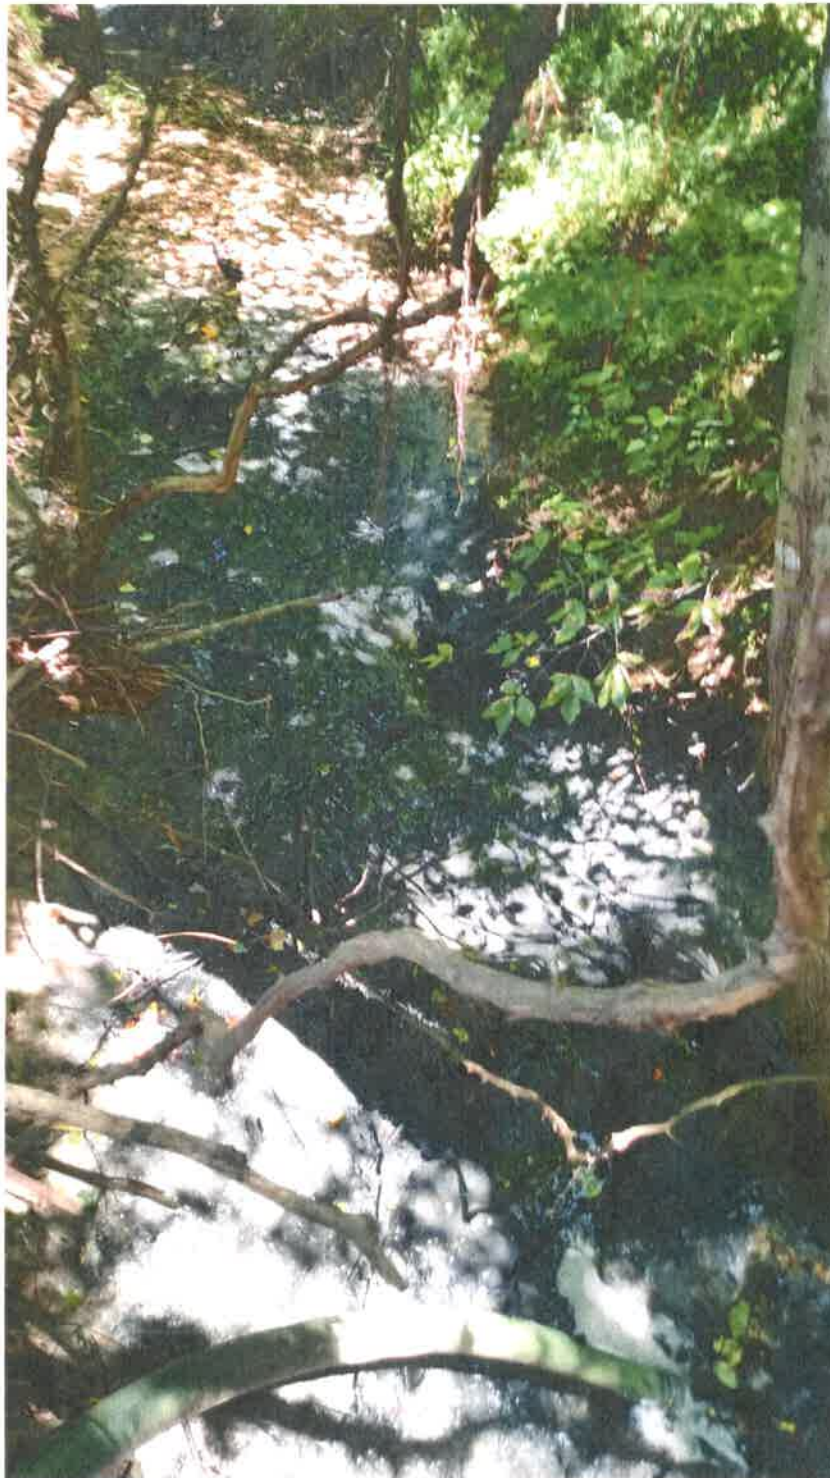
Picture 25

Picture provided by Mr. Chuck Hayes on July 27, 2016 after drainage ditch was pumped out a second time.

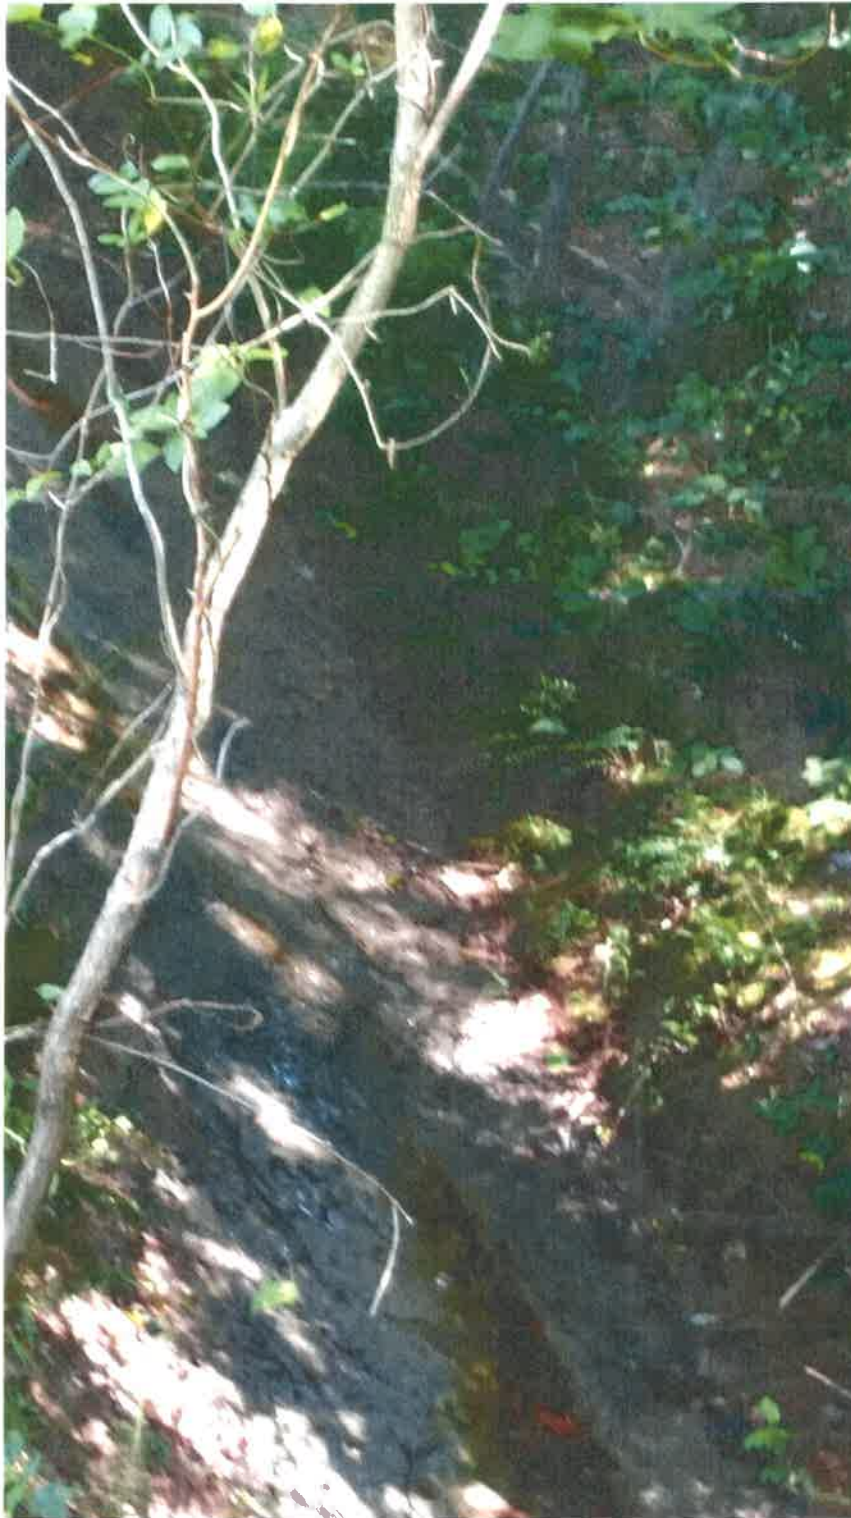
Picture 26

Picture provided by Mr. Chuck Hayes on July 27, 2016 after drainage ditch was pumped out a second time.
